Second Row Seat Squeak

Service Category Vehicle Interior

YEAR(S)	MODEL(S)	ADDITIONAL INFORMATION
2010 – 2015	GX460

REVISION NOTICE

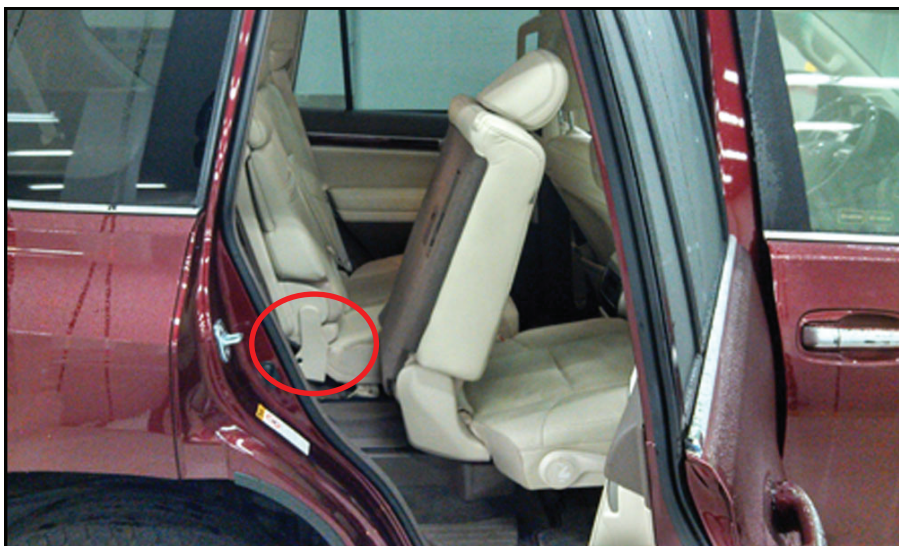
Figure 1.

Some 2010 – 2015 model year GX 460 vehicles may exhibit a squeak noise coming from the second row seats when driving over uneven terrain. The bracket for the inside hinge of the 60% second row seat may rub the seat frame. Follow the procedure outlined below to address this condition.
